Walsh Appliances, 26 Courtenay Street

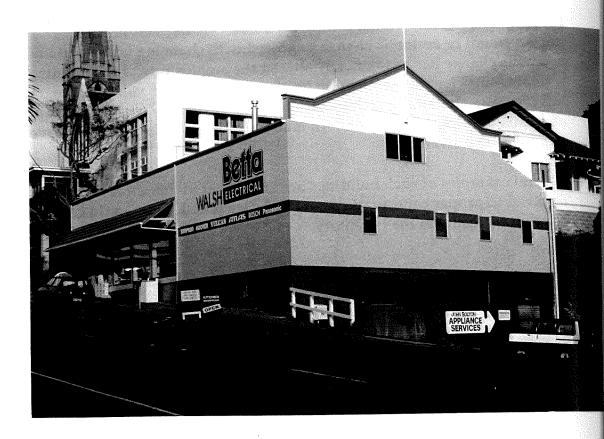
Walsh Appliances is now a showroom, and is clad in modern sheet materials. It was built in 1919 as a Workers Social Hall, and in its original form was clad in lapped weatherboards with tall double-hung windows. The hall itself, including the roof trusses and boarding, remains relatively unmodified. Because of this, and the fact that the form of the building is intact, it would be possible to restore some authenticity to a building of considerable social, historical and architectura importance.
